CWA COMPLIANCE EVALUATION INSPECTION REPORT
U.S. ENVIRONMENTAL PROTECTION AGENCY, REGION 5

Purpose:
Compliance Evaluation Sampling Inspection

Facility:

Date of Inspection: June 19, 2019

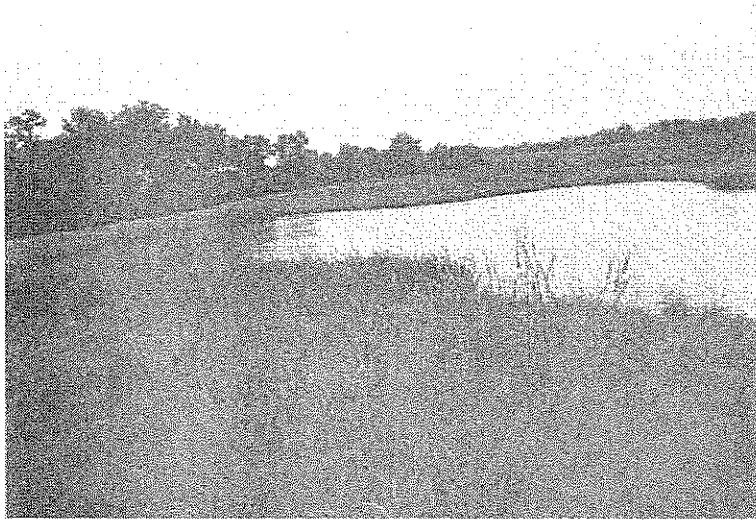
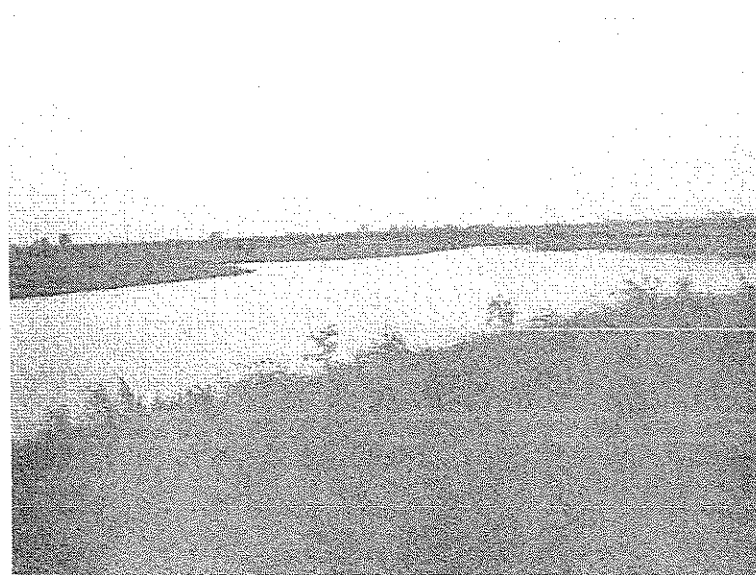
3: 20190619_110542

Description: Looking at the pond from south to northwest in photos 3 and 4.

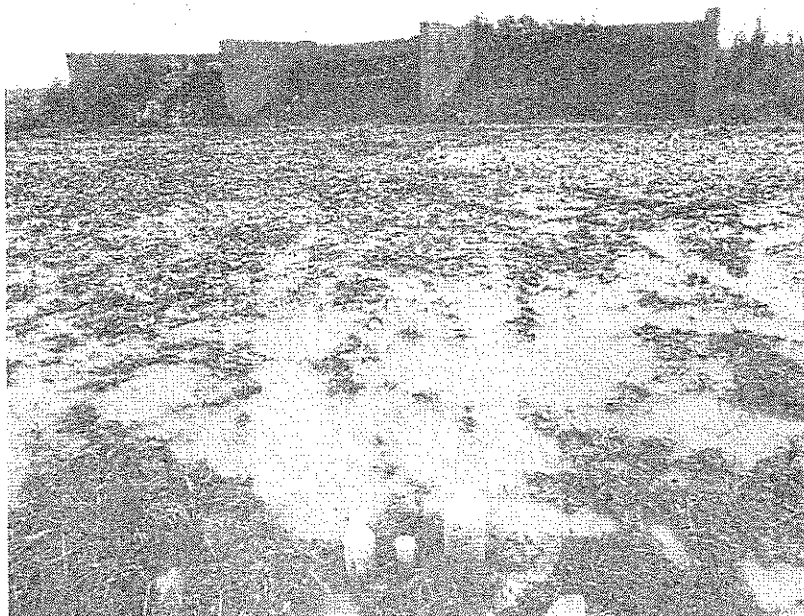
6: 20190619_112319

Description: Sample S01, named "Compost Runoff" was taken at 11:20 a.m. from the flow of process wastewater from the Mortality Compost Bin to the pond.

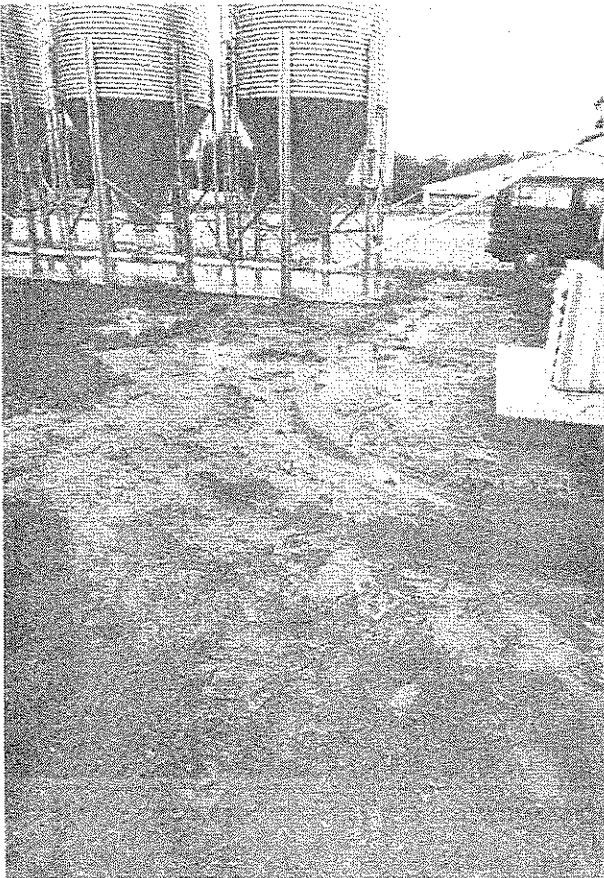
10: 20190619_113533

At the southeast corner of the North Barn on the East Site, EPA observed a denuded area near the pit fan with flow channels that flowed to the south, to the facility parking area. EPA did not observe these channels reach the pond to the southwest. In fact, the parking area was flooded near the north side of the South Barn and did not appear to have an outlet.

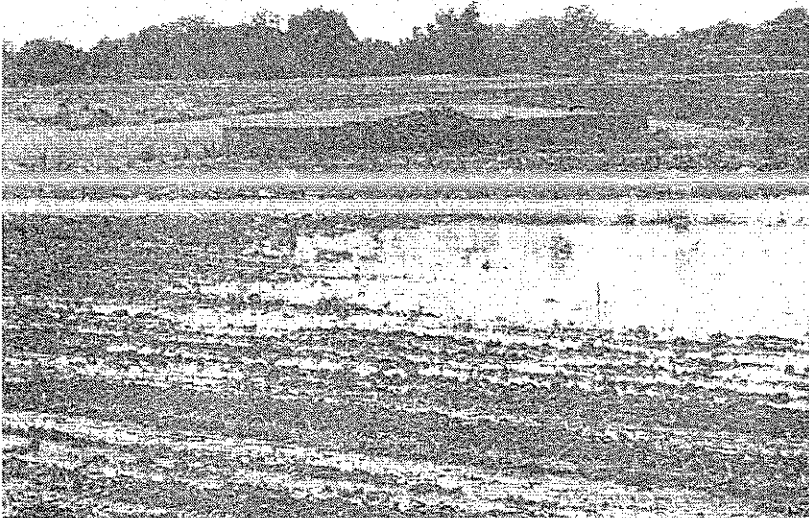
11: 20190619_113806

Description: Turkey vulture on the Mortality Compost Bin.

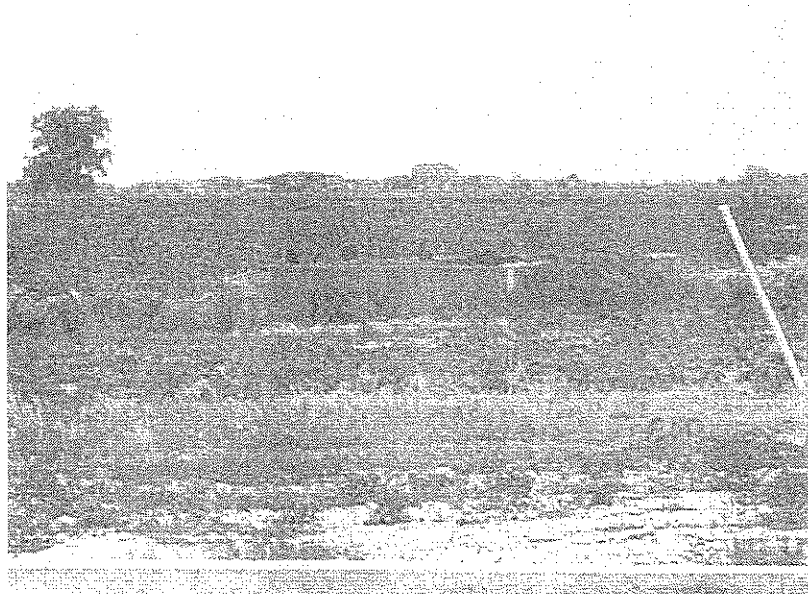
13: 20190619_122342

Description: At least six turkey vultures on the Mortality Compost Bin.

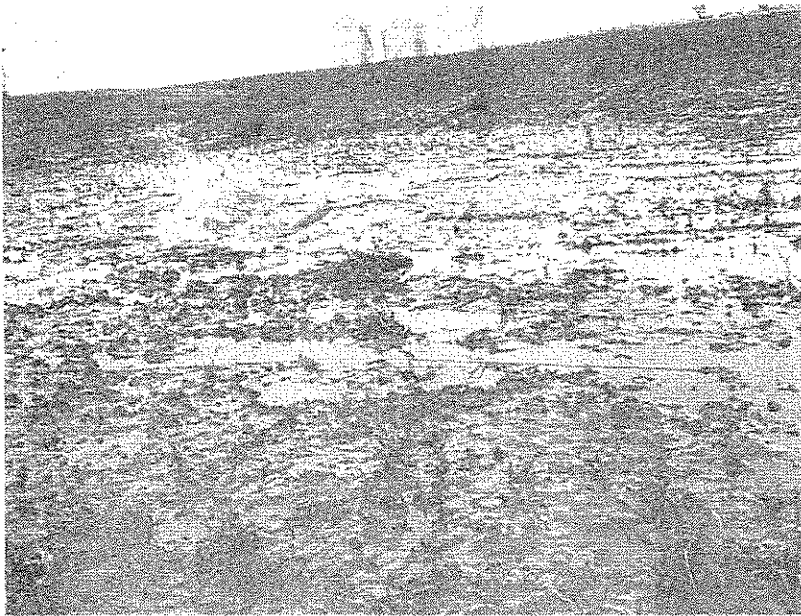
16: 20190619_123759

Description: Red arrow denotes the direction of flow through the crop field from the south side of the barn on the West Site.

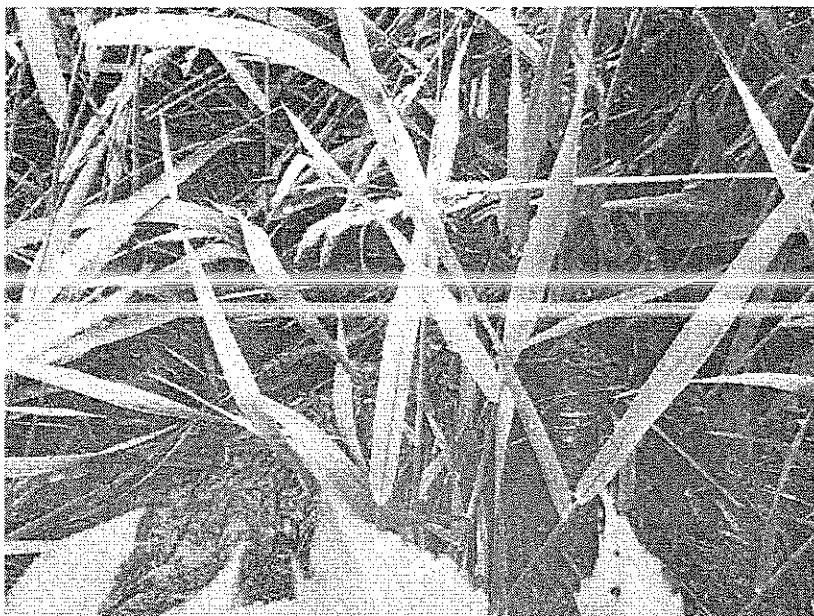
18: 20190619_123908

Description: Flow channelizes and goes under the fence at the west side of the crop field.

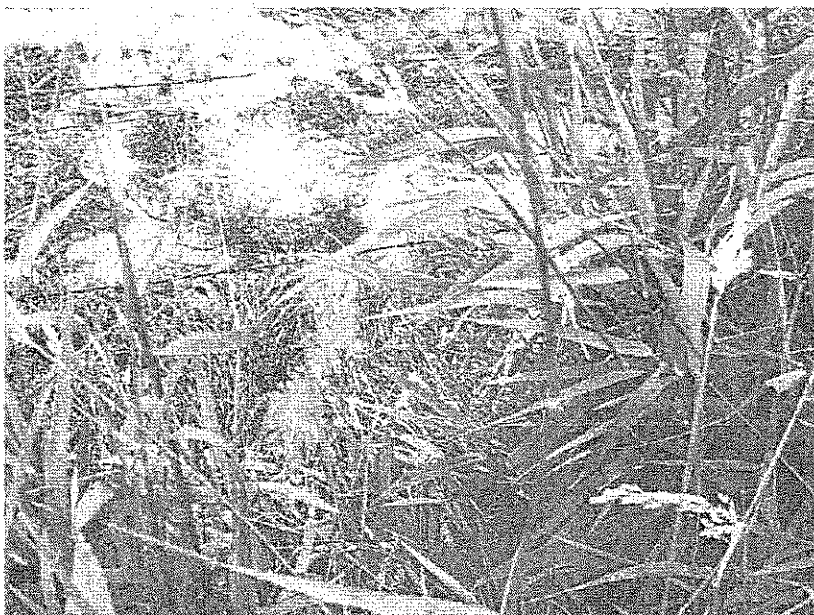
19: 20190619_123915

Description: Flow channelizes and goes under the fence at the west side of the crop field.

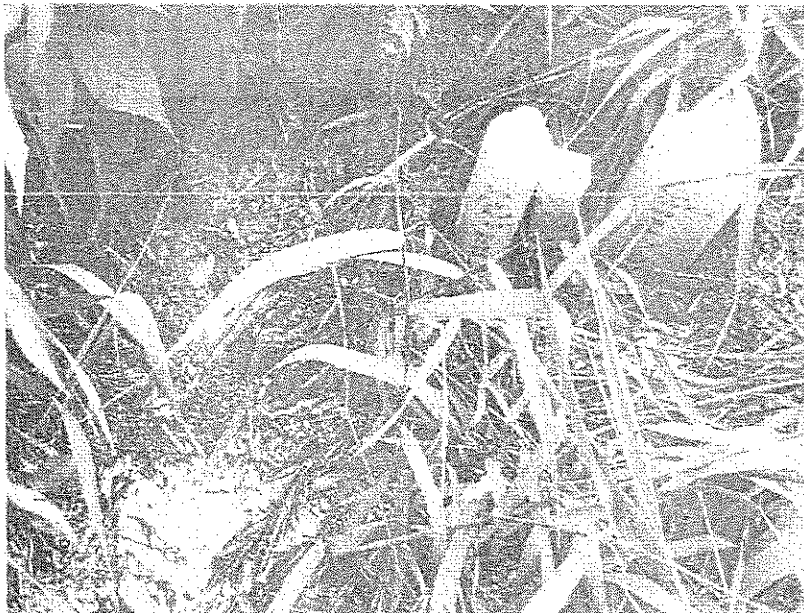
21: 20190619_125116

EPA then took sample S02, named "Field Runoff" at 12:47 p.m. from the flow of liquid under the fence and to the pond. EPA walked back to the vehicle and preserved the sample at 12:56 p.m.

Description: Sample S02, "Field Runoff" was taken at 12:47 p.m. from the flow channel at the fenceline.

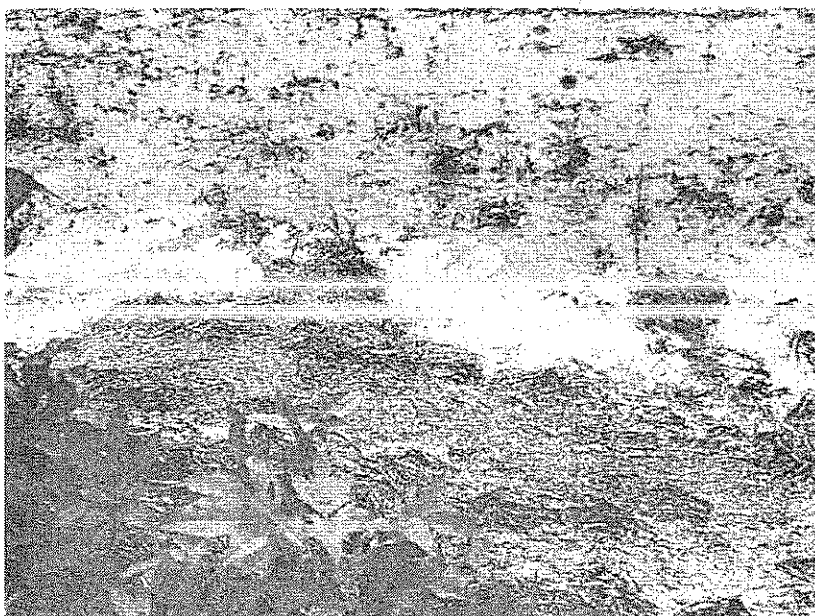
22: 20190619_125121

Description: Photo of the light brown and white foam and solids in the flow pathway through the crop field.
